# **FIRE SUPPRESSION SERVICES, INC.**

## **EXHAUST DUCT DEFICIENCIES.**

The grease exhaust ducting you asked me to inspect at Heritage Gardens Care Center in Springville Utah was, for the most part, inaccessible for inspection.

## **RANGE GUARD SUPPRESSION SYSTEM DEFICIENCIES.**

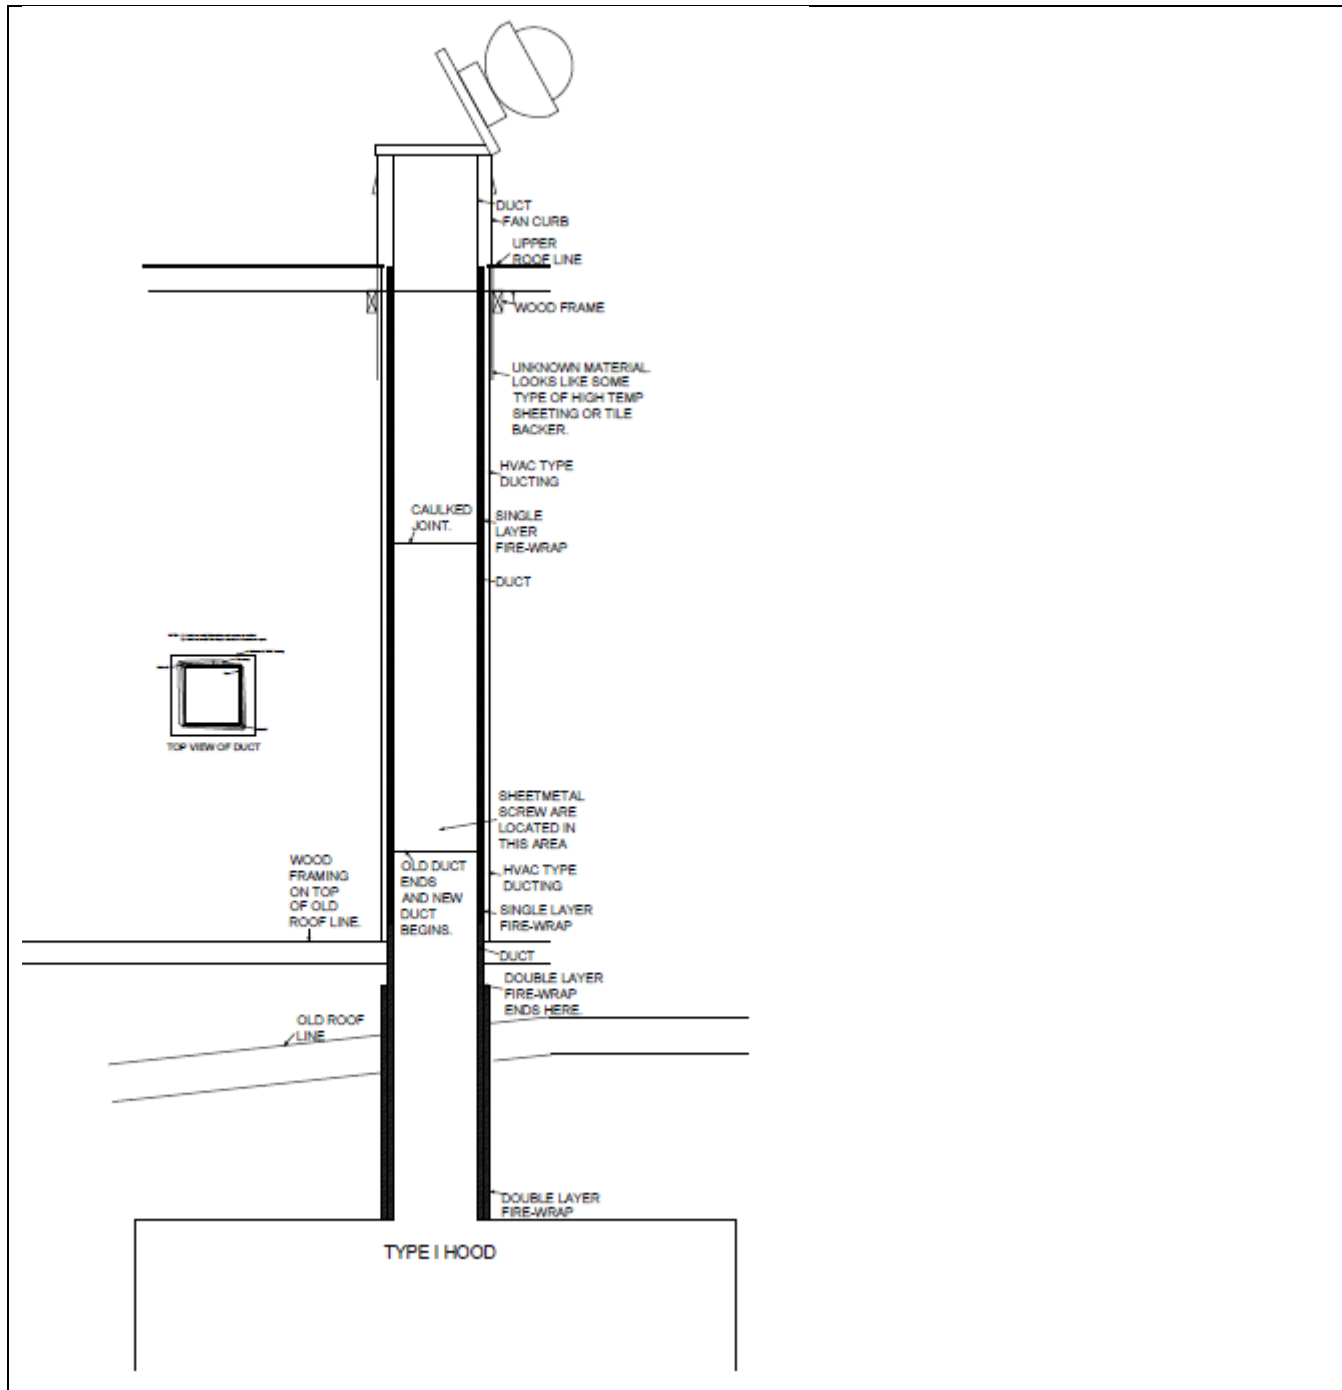
### Overall view: Heritage Gardens Springville Kitchen Hood Exhaust

NOTES: (1) Could not verify if duct joints and seams are welded.  
(2) Could not verify if fire-wrap is banded or if seams are taped.

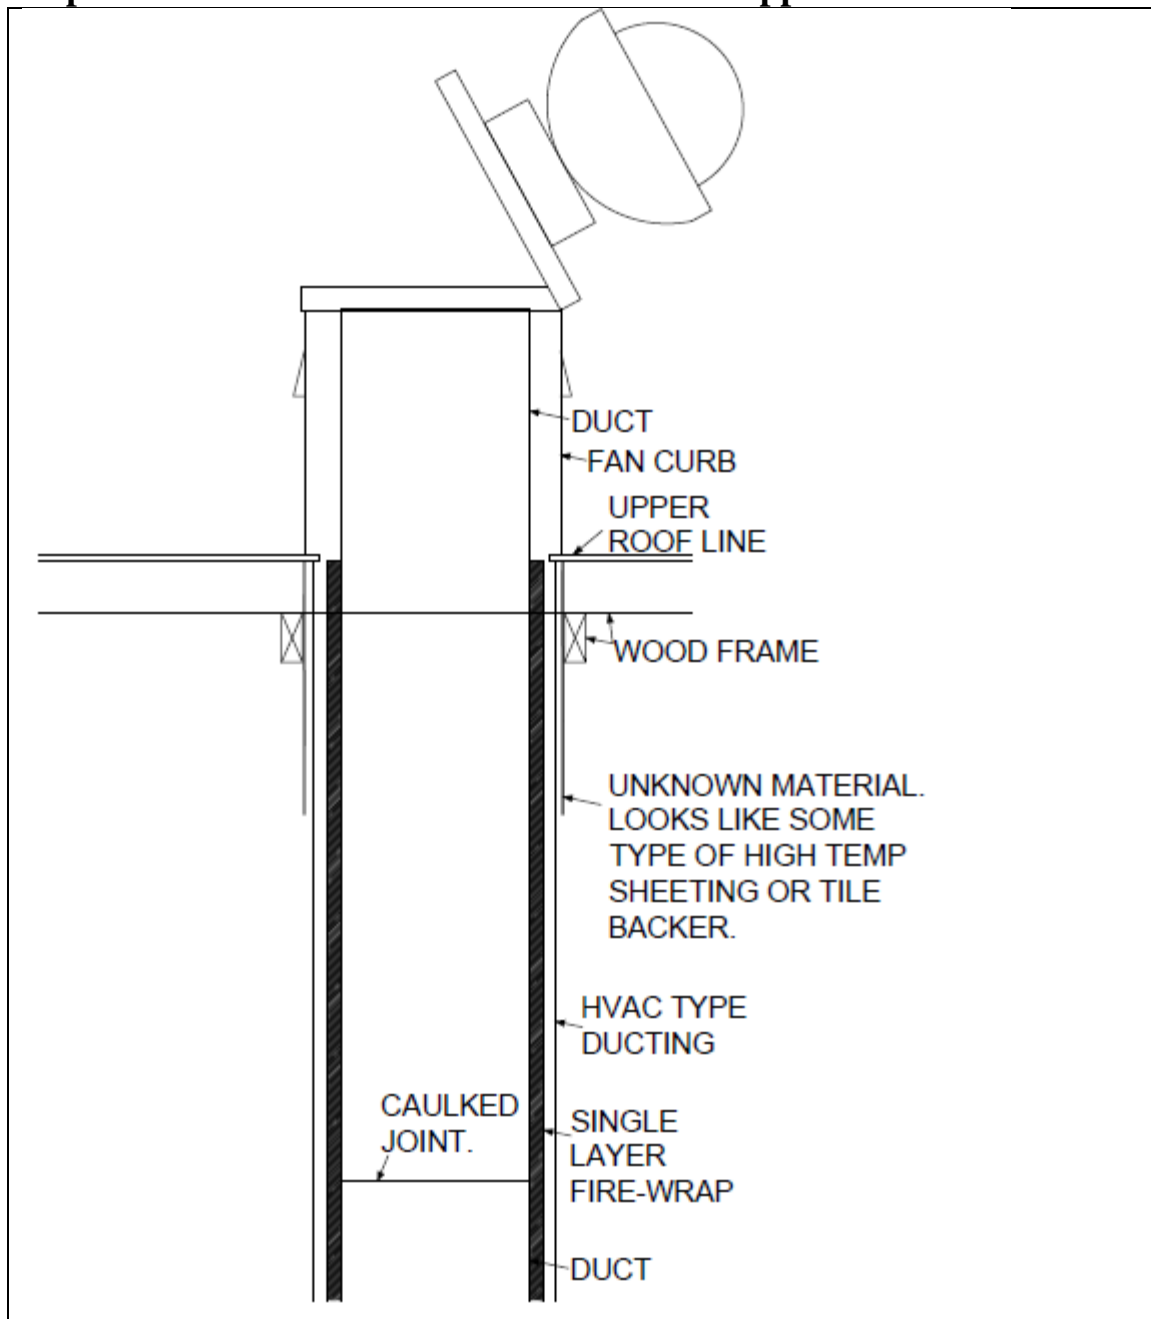
## Expanded view of a Section of Duct: Fan & upper duct

I was able to determine the new upper portion had 1 layer of fire-wrap but it did not extend to the upper end of the duct into the fan curb.

From the upper end of the duct I could see that caulk had been used in the seams and joints however I was unable to determine if they had been welded.

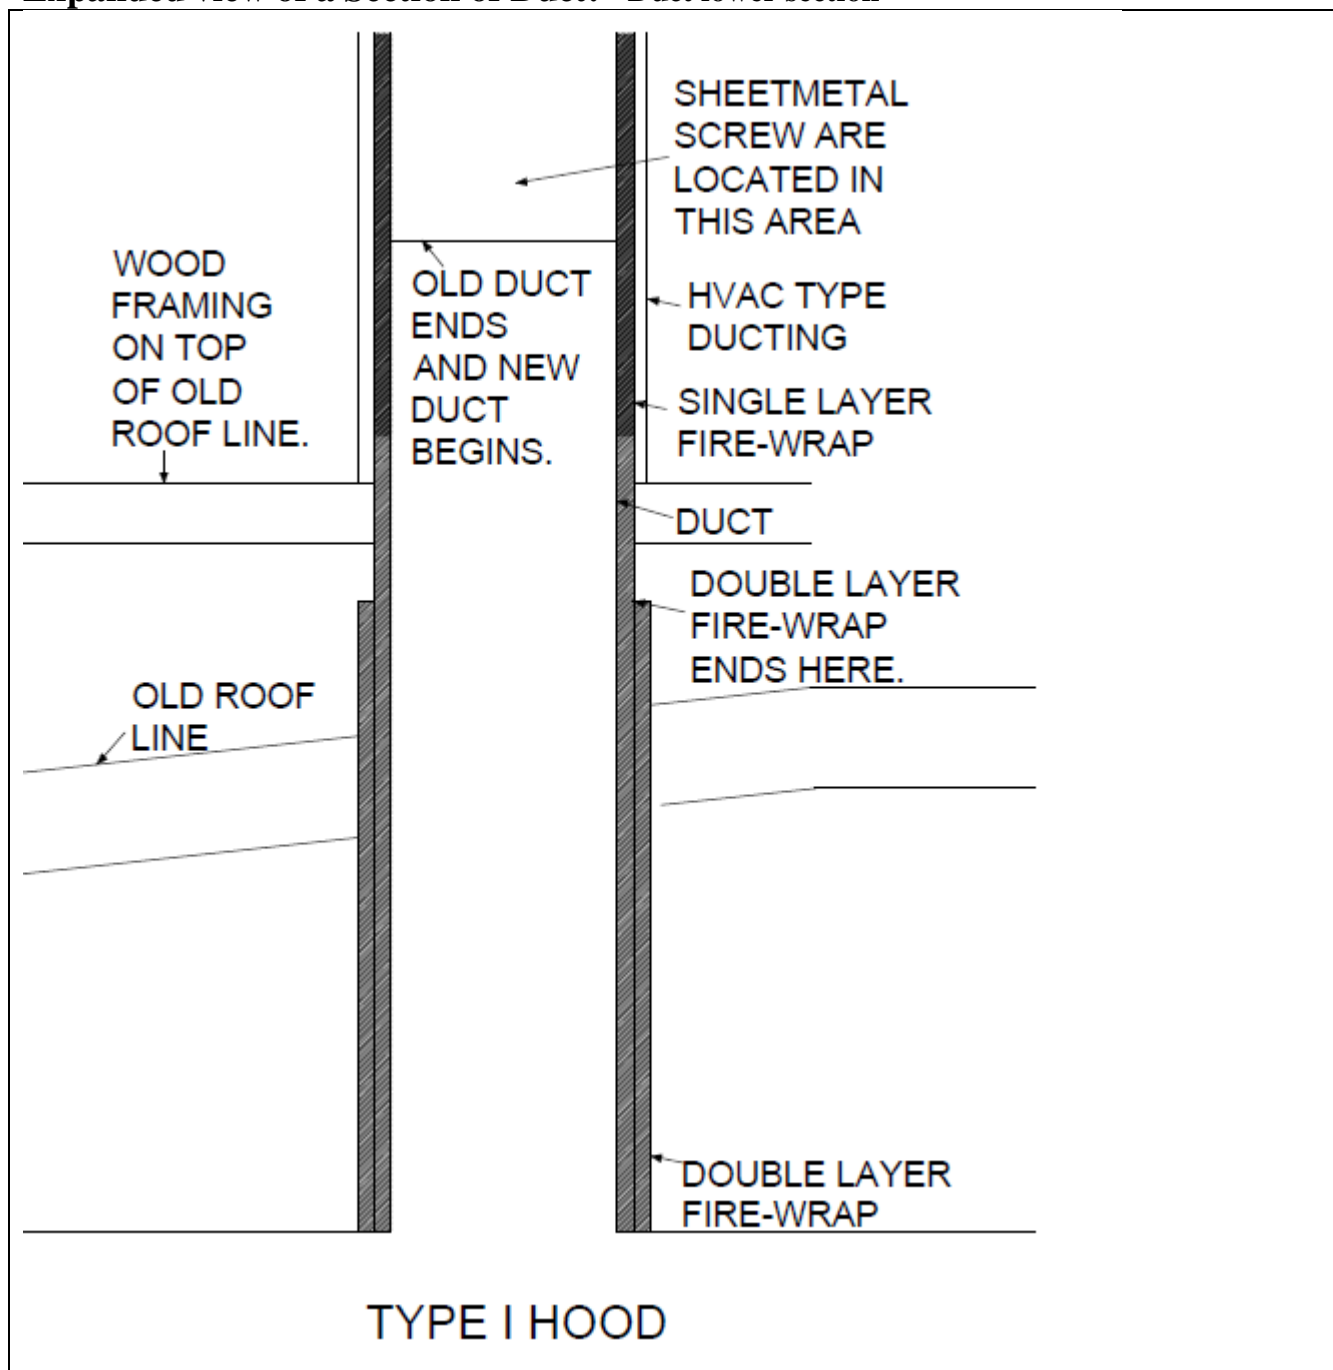
## Expanded view of a Section of Duct: Duct lower section

I could see that the older portion had been welded to the hood from inside the plenum; the seams were welded, and had 2 layers of fire-wrap.

I also could see screw tips inside the new duct just above the joint where the old duct and new duct connect. I could not get to the material that hangs down 18" from the roof line that surrounds the outer HVAC ducting to determine what it was.

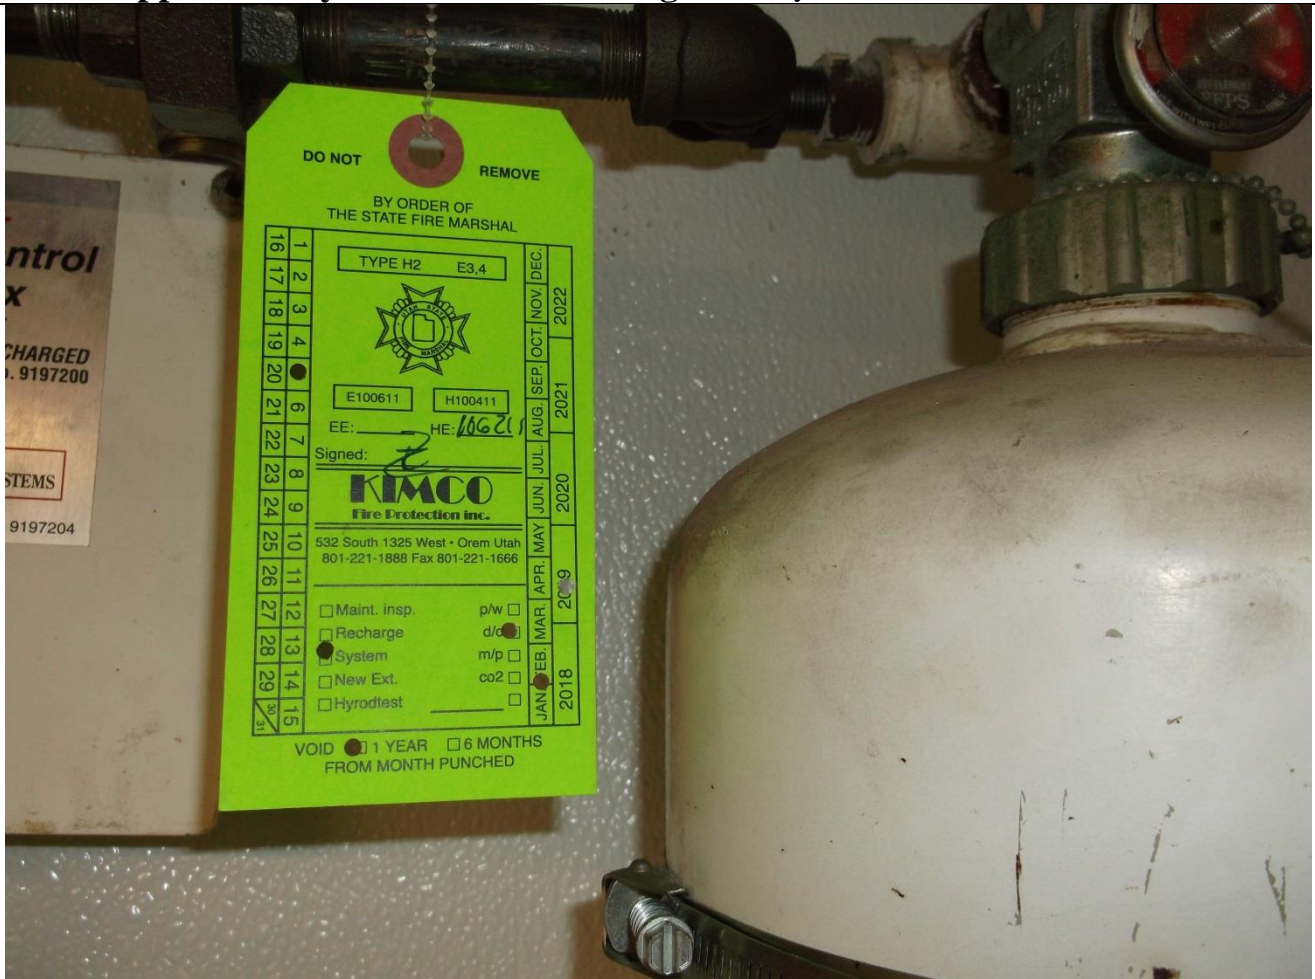
KIMCO Fire Protection Inc. tags are attached to the kitchen hood suppression system (dated February 5, 2019). Note from my photo the tag was punched D/C (*dry chemical*).

## Kitchen Suppression System with KimCo tags as a Dry Chem?

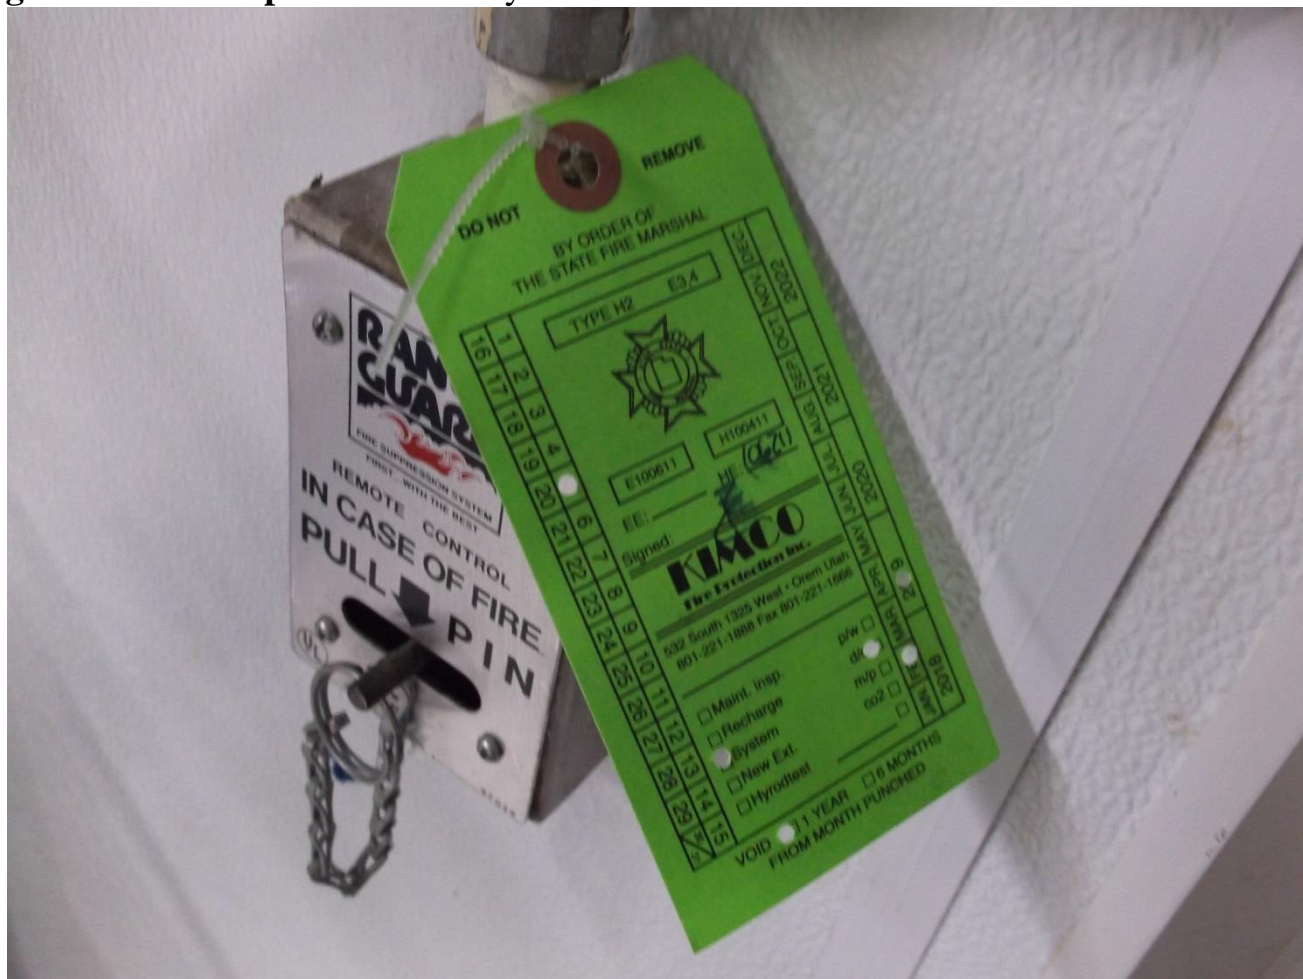
At the time this system was installed, “End-of-Line” pull-stations were permitted along with high-proximity nozzles protecting open-burner ranges with back-shelves.

Current manufacturers’ specifications do not allow “End-of-Line” pull-stations and require “Low Proximity” nozzles under the range shelf to protect open-burner ranges with shelves.

The pull-station is no longer on a route of egress. The exterior door that was the route of egress has been framed over and is no longer an exit.

There is not a location inside the kitchen that is in the 10’ – 20’ from the hood where it can be located and may need to be moved to the dining area to meet that standard.

## Tag on end-of-line pull station: Dry chem?

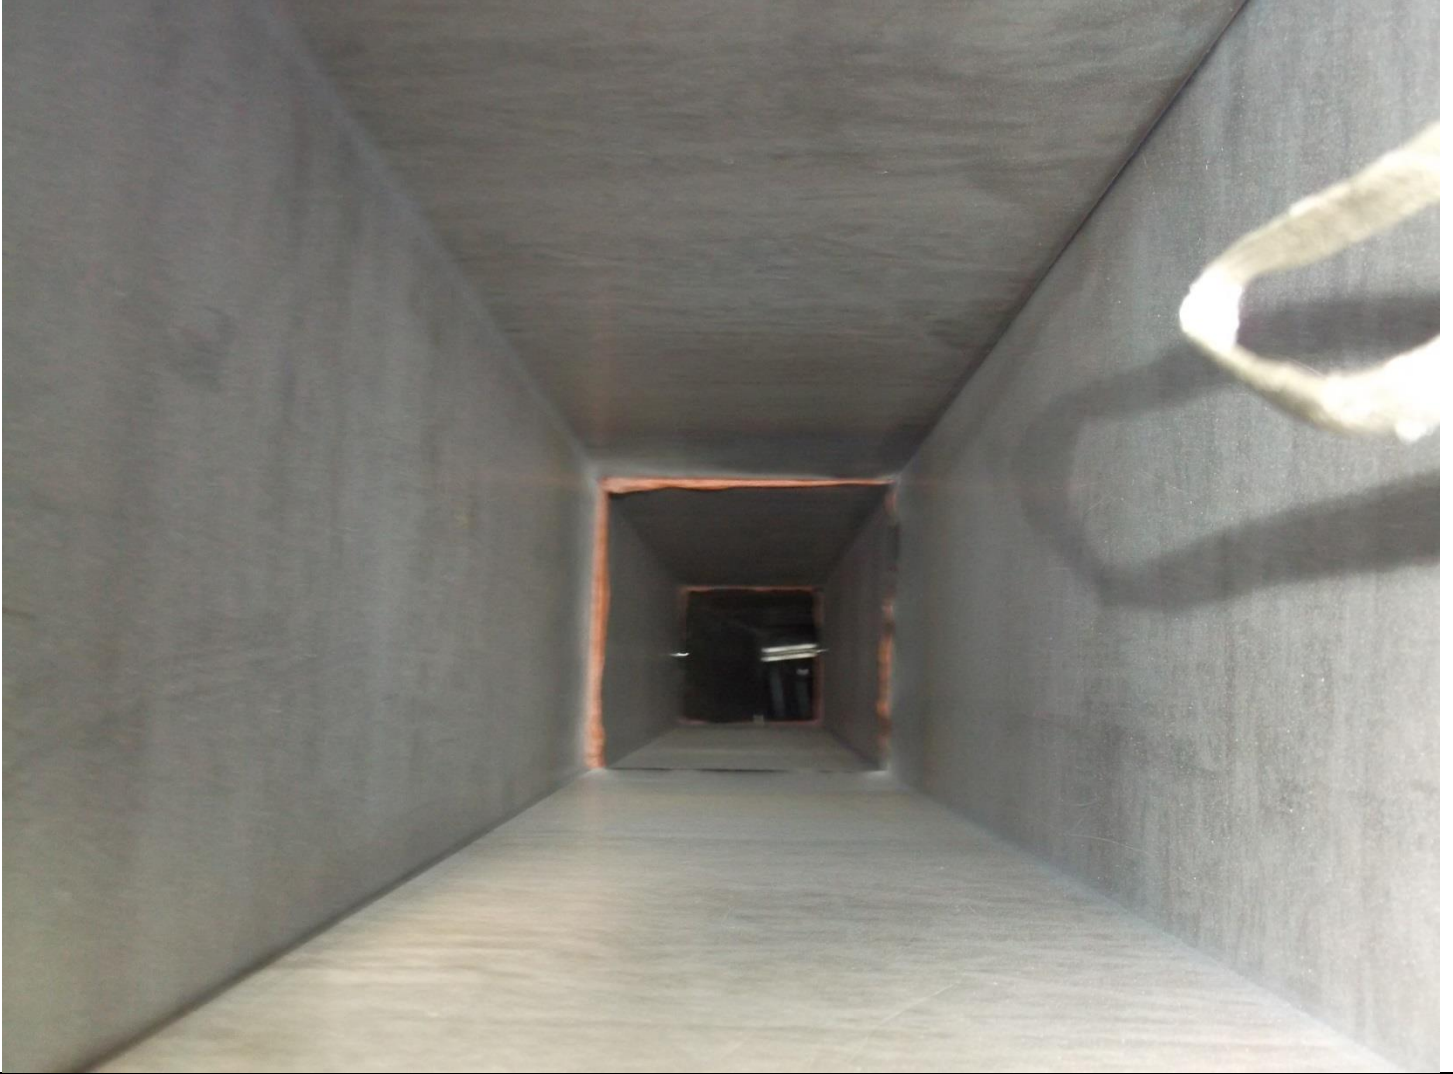
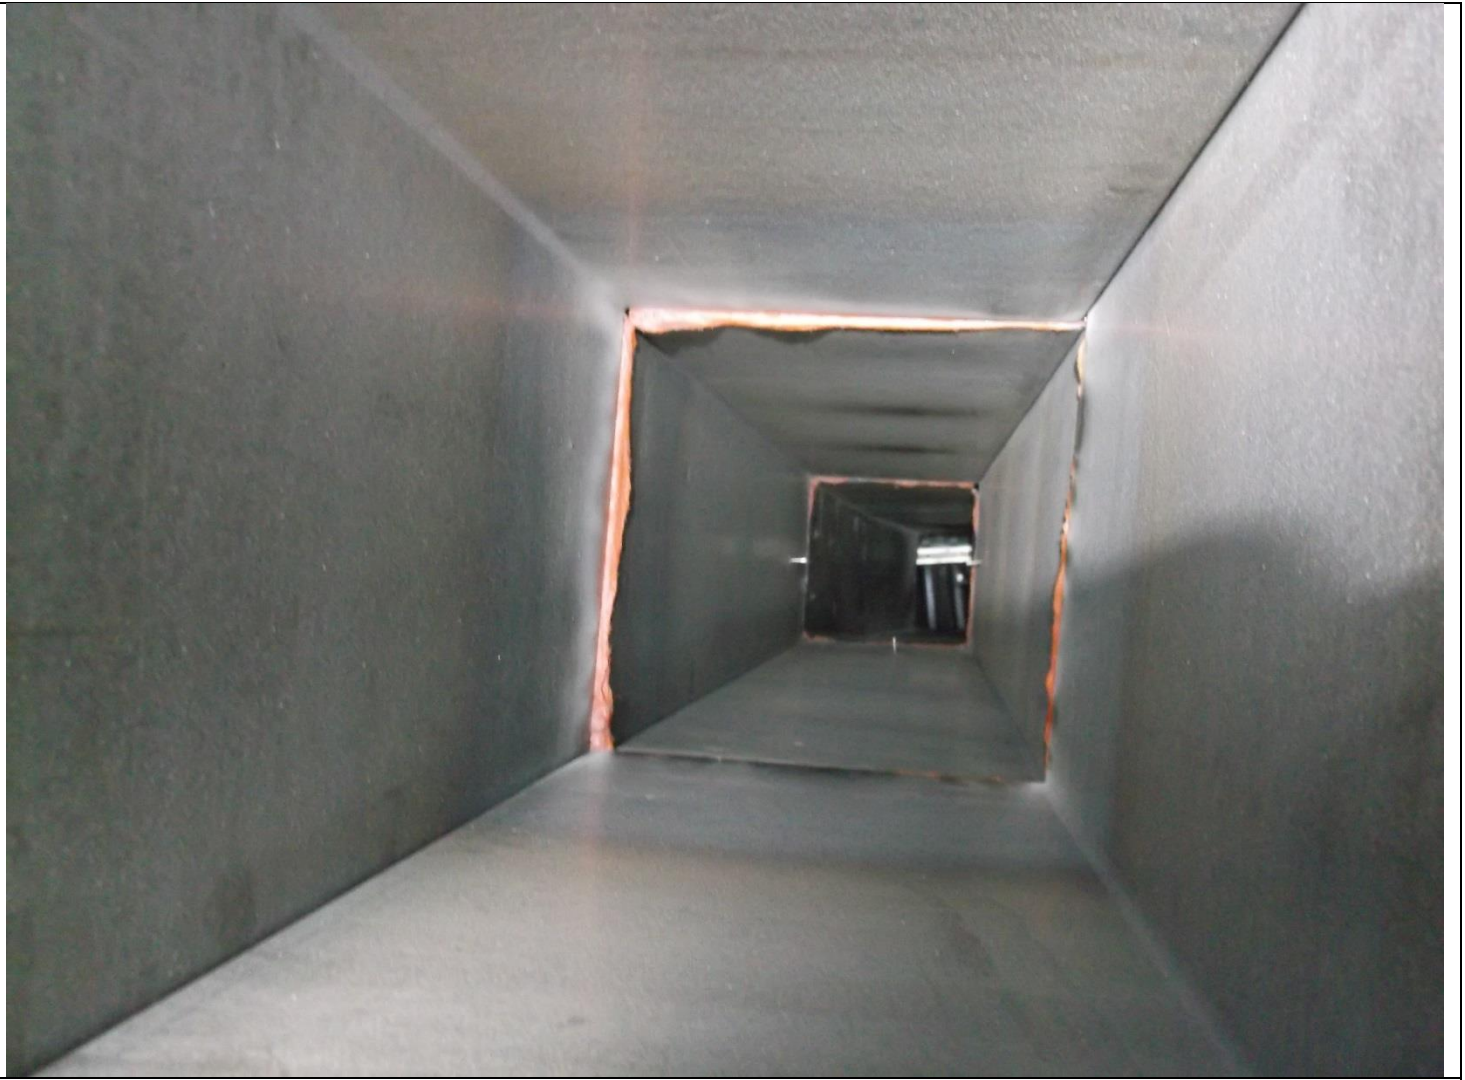
## Caulk in seams

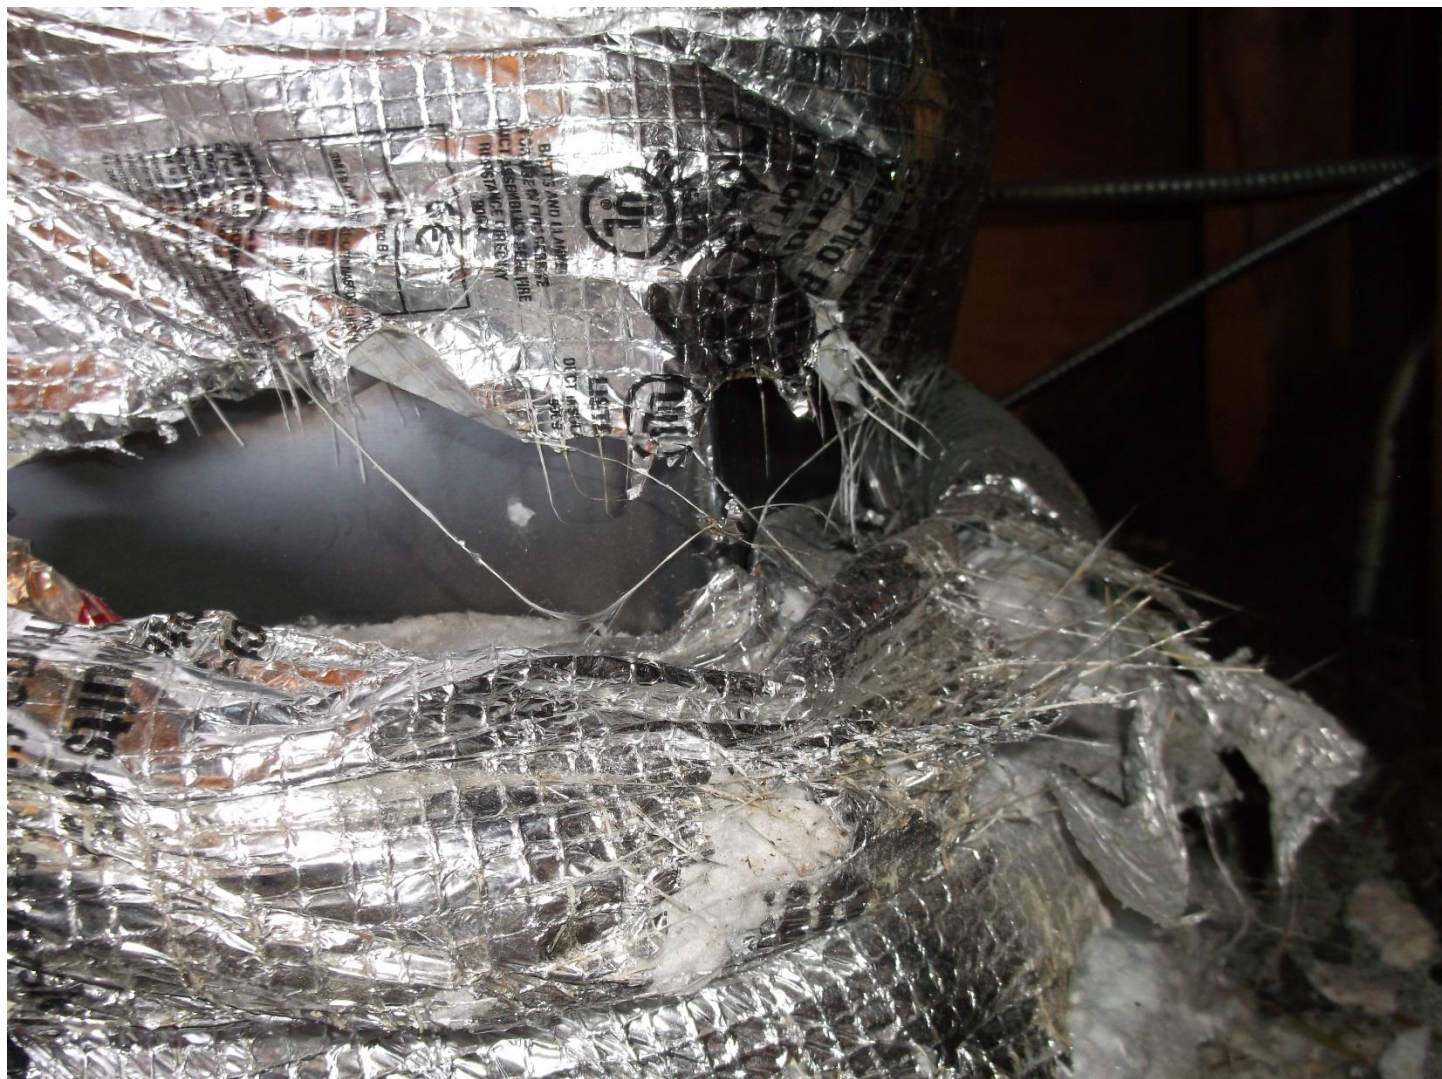
## Lower duct seam weld

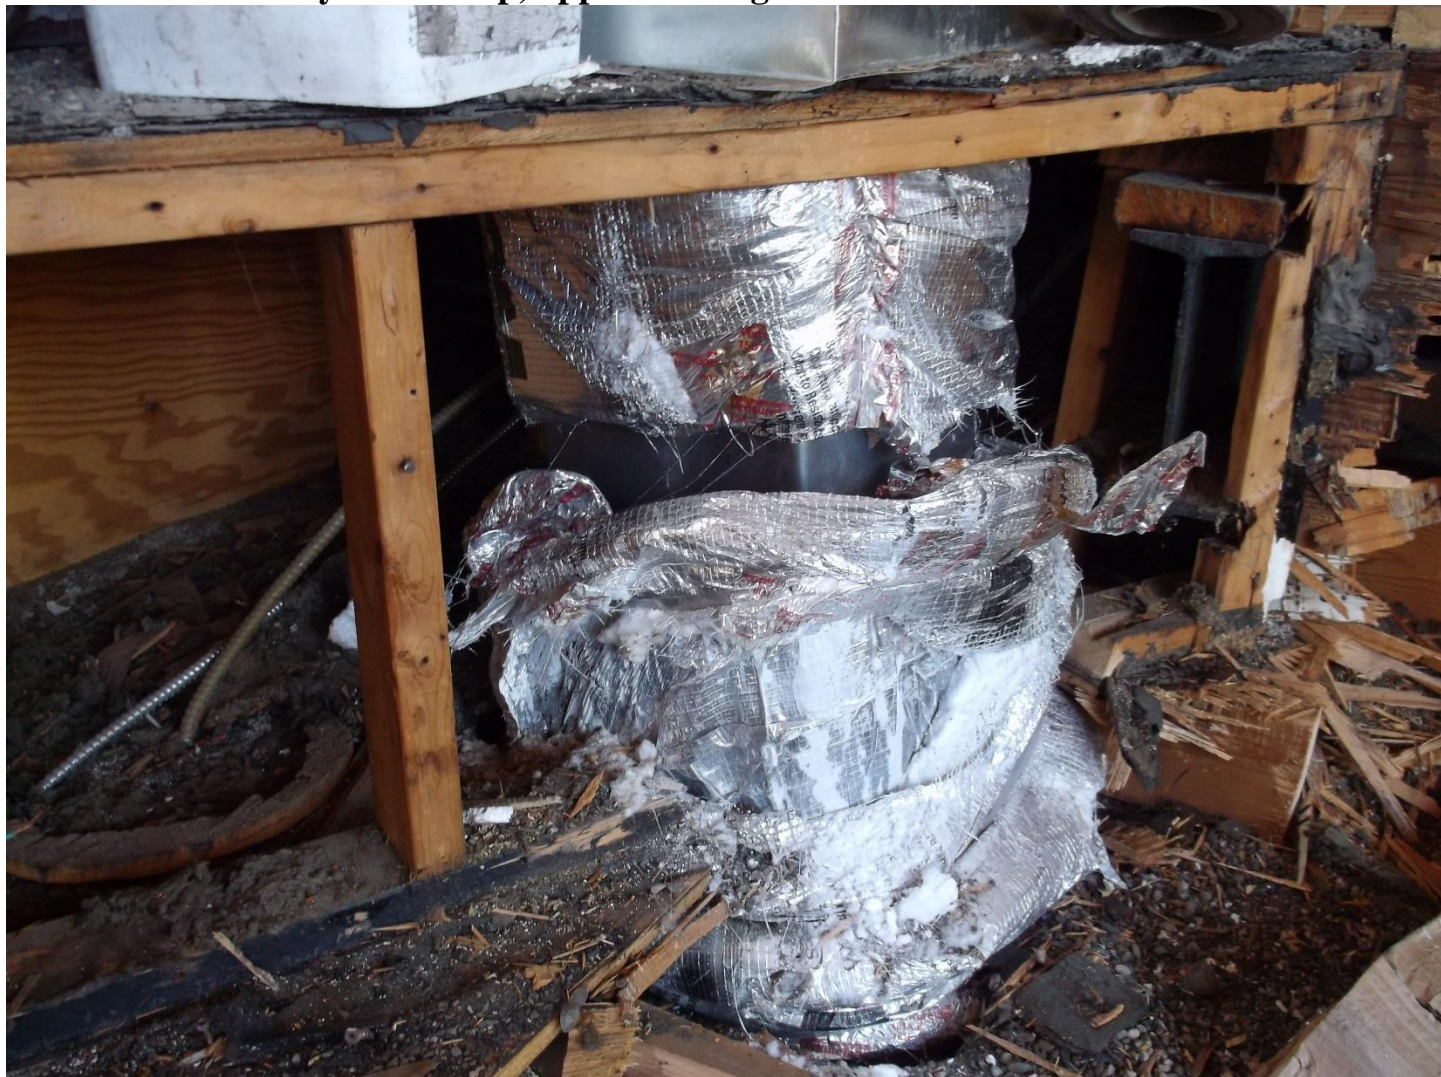
I could not verify if the upper fire-wrap is banded or whether the seams and joints are taped. They must be overlapping, taped and banded as per manufactures specs. (Code)

**Lower duct has 2 layers of wrap, upper has single**

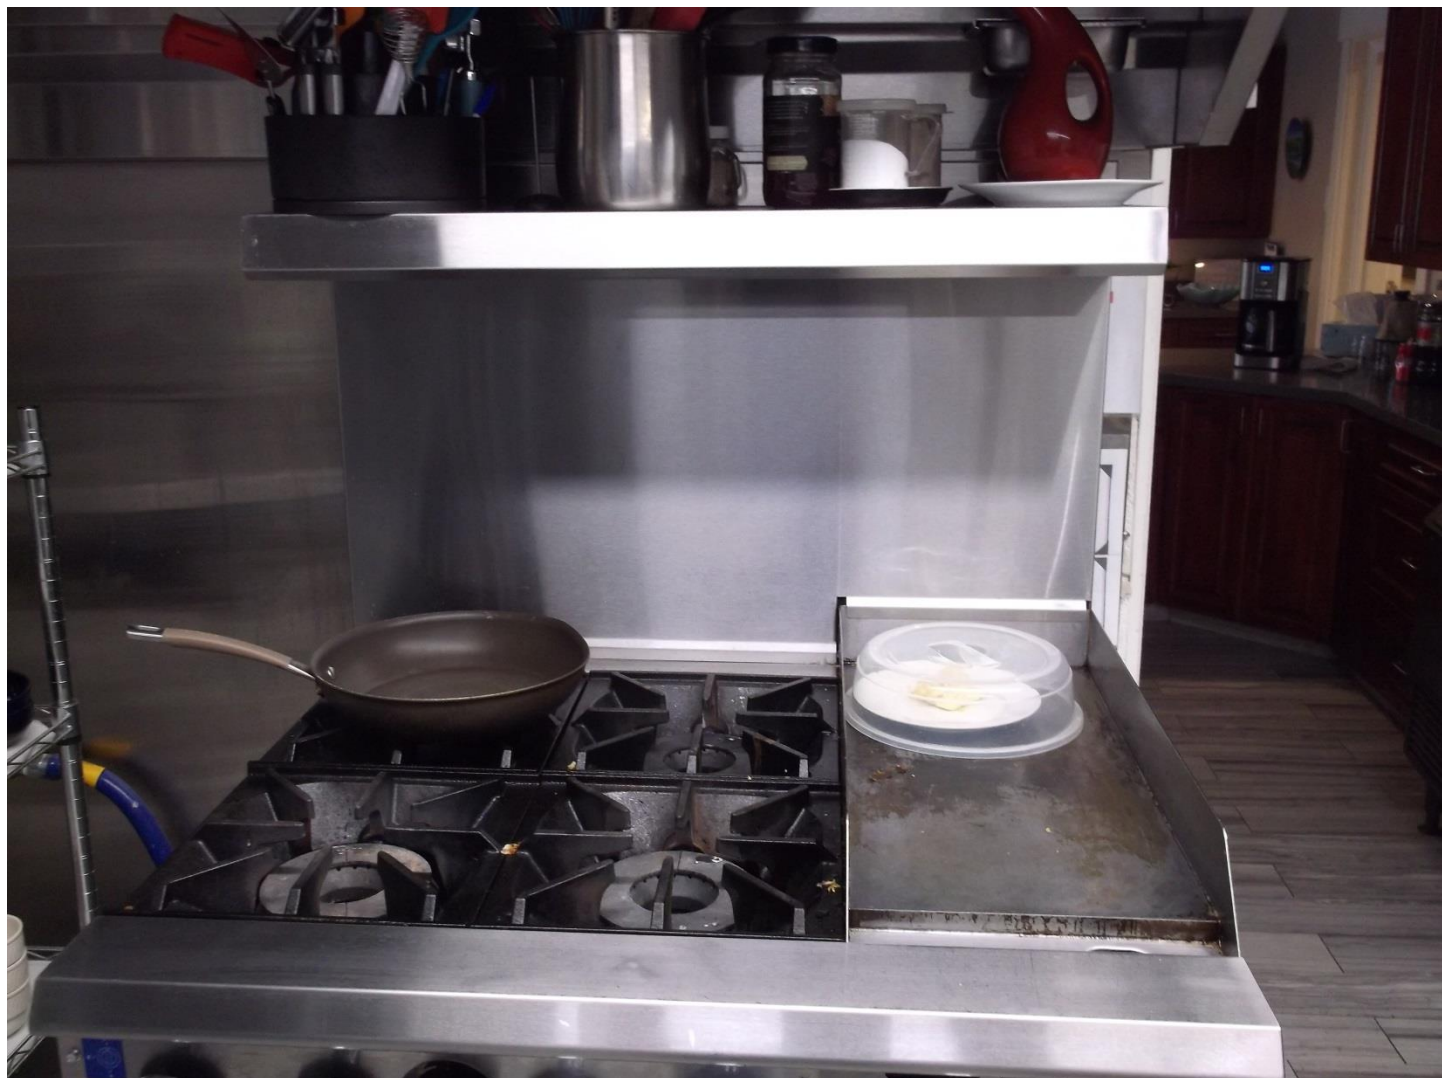
The range had been moved to the right end of the hood from the location where it was when the nozzles were installed.

## Combo range with shelf

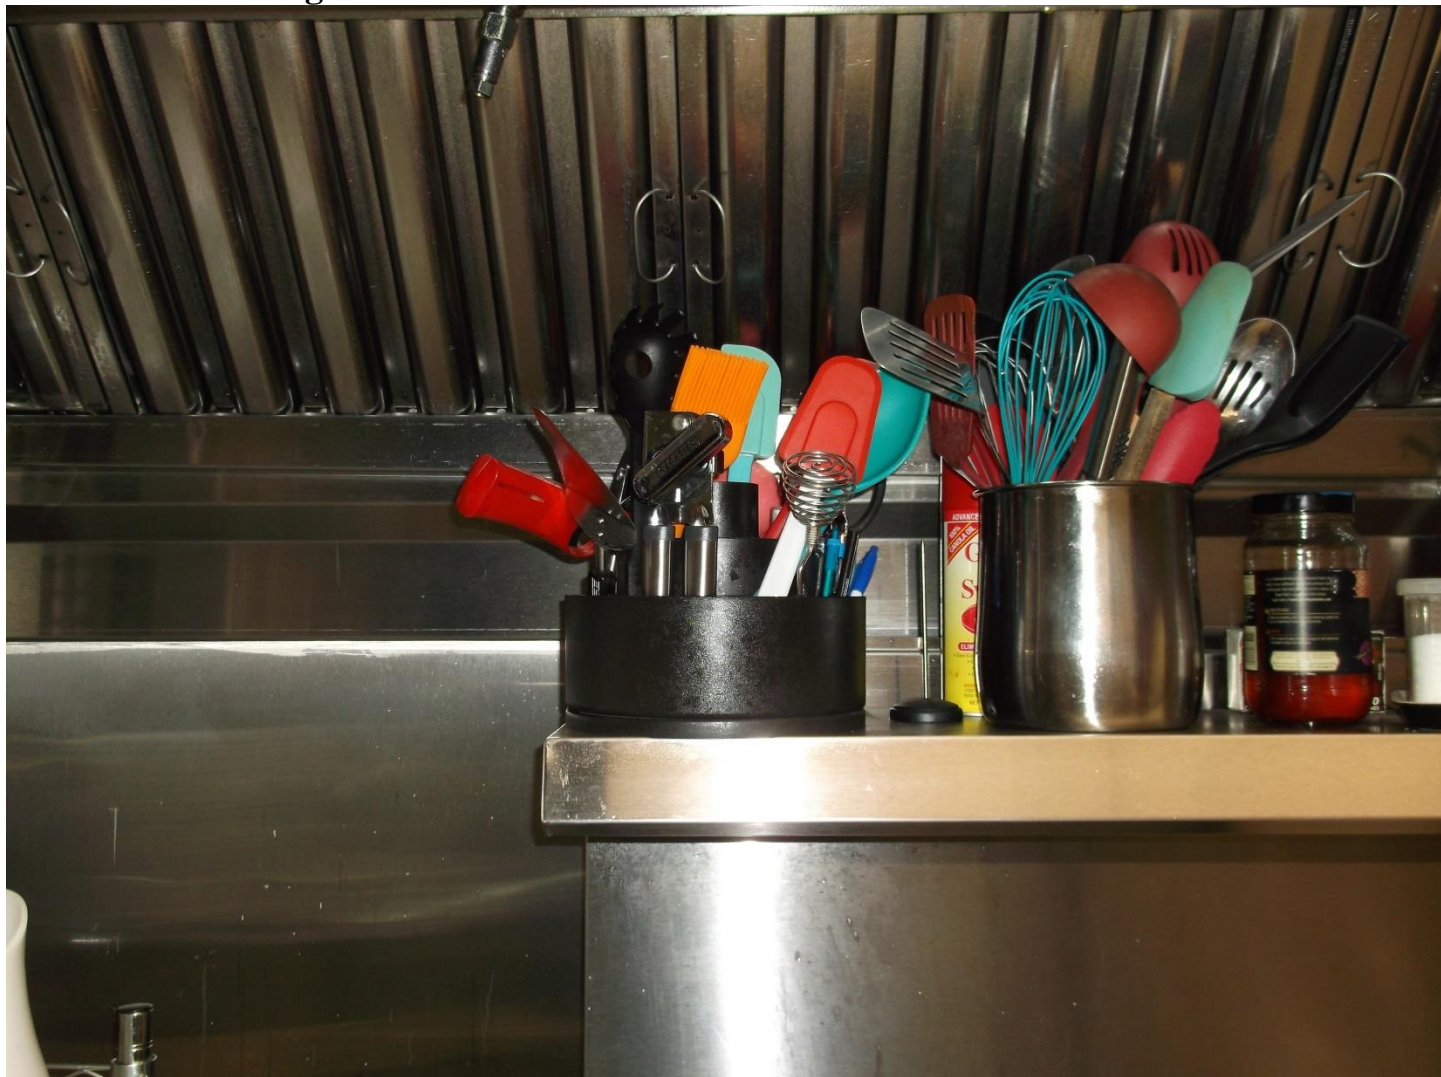
The current appliance nozzle locations and aiming is not correct.

## Nozzle over nothing

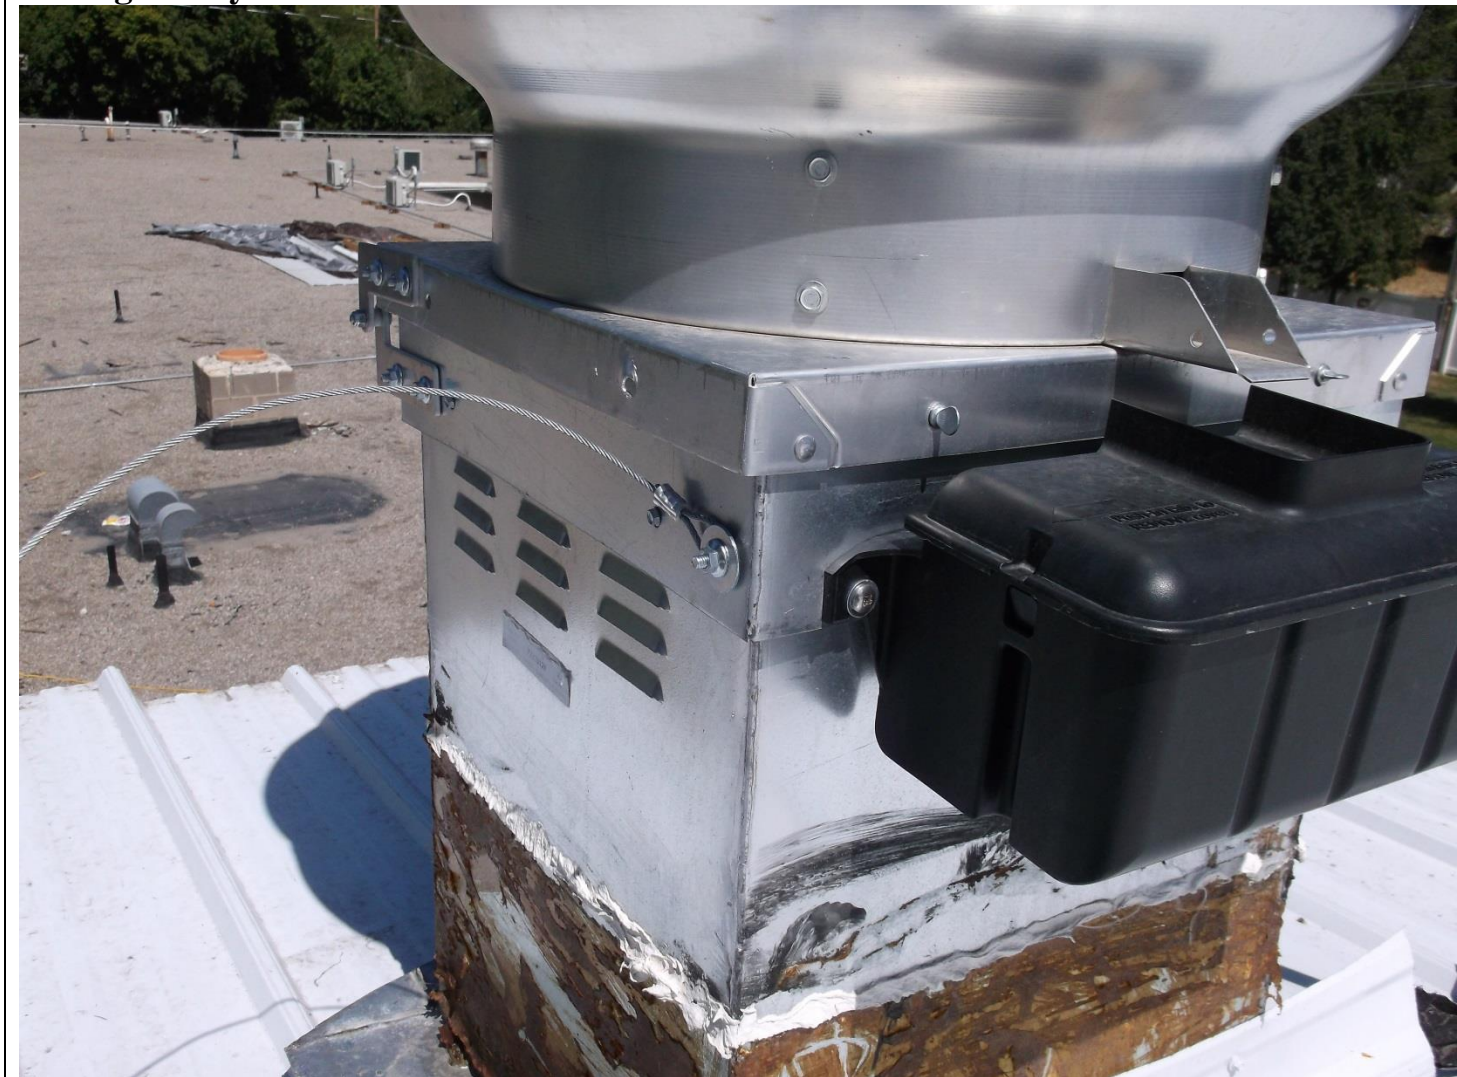
## Damaged lanyard roof fan

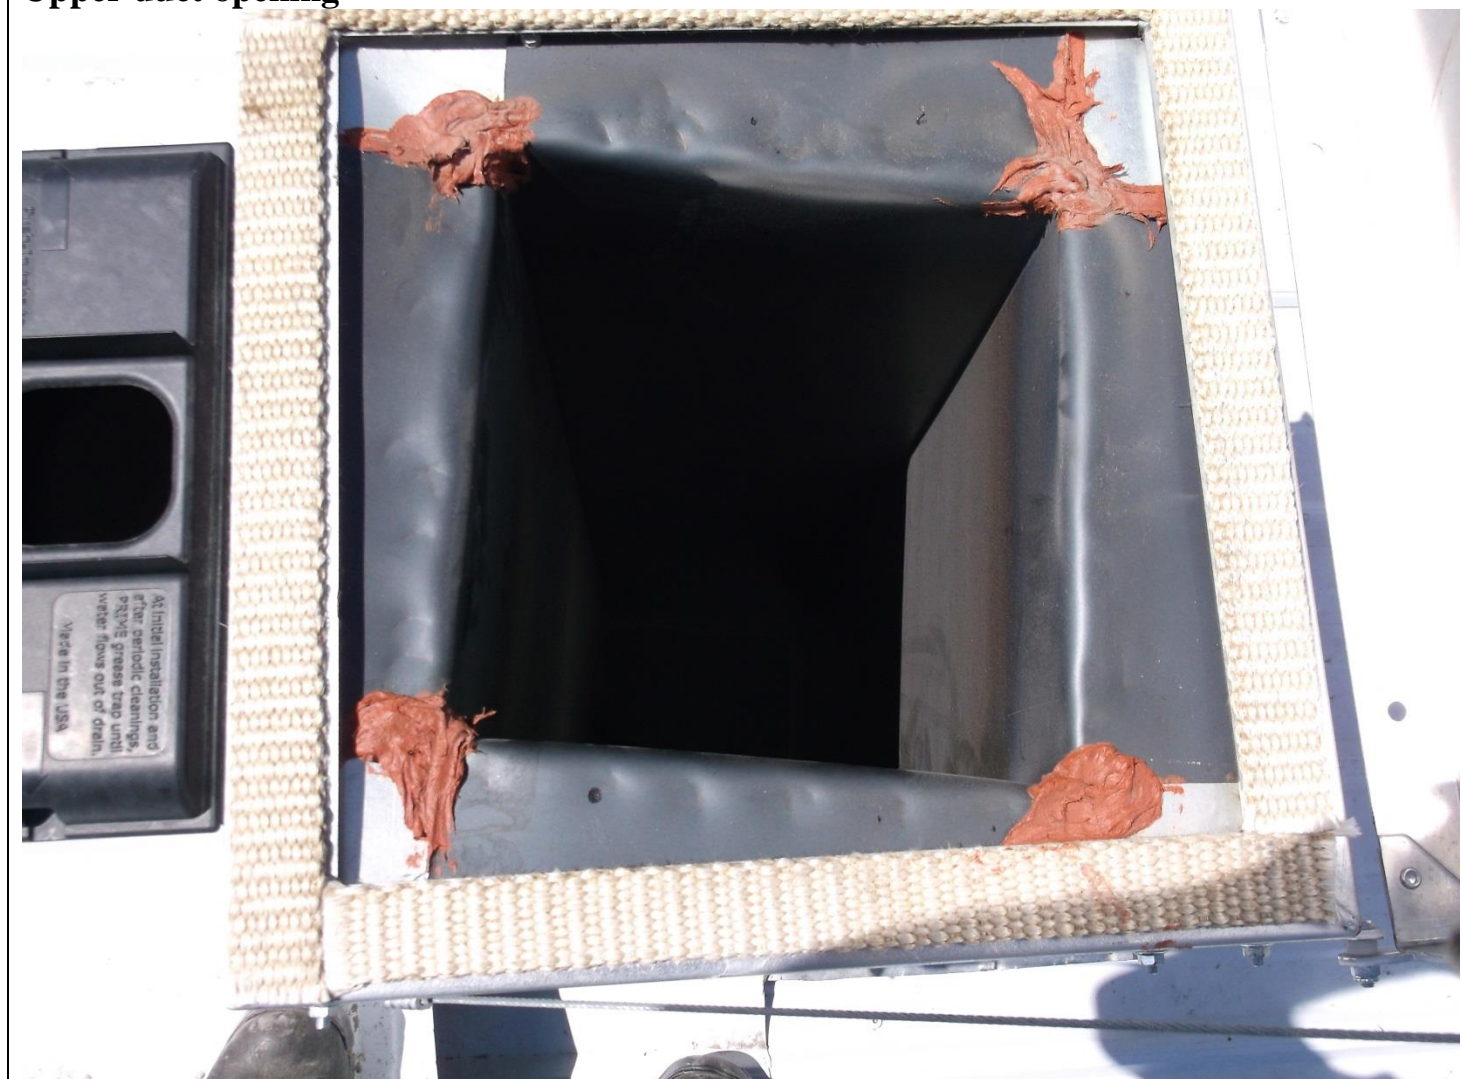
## Upper duct opening

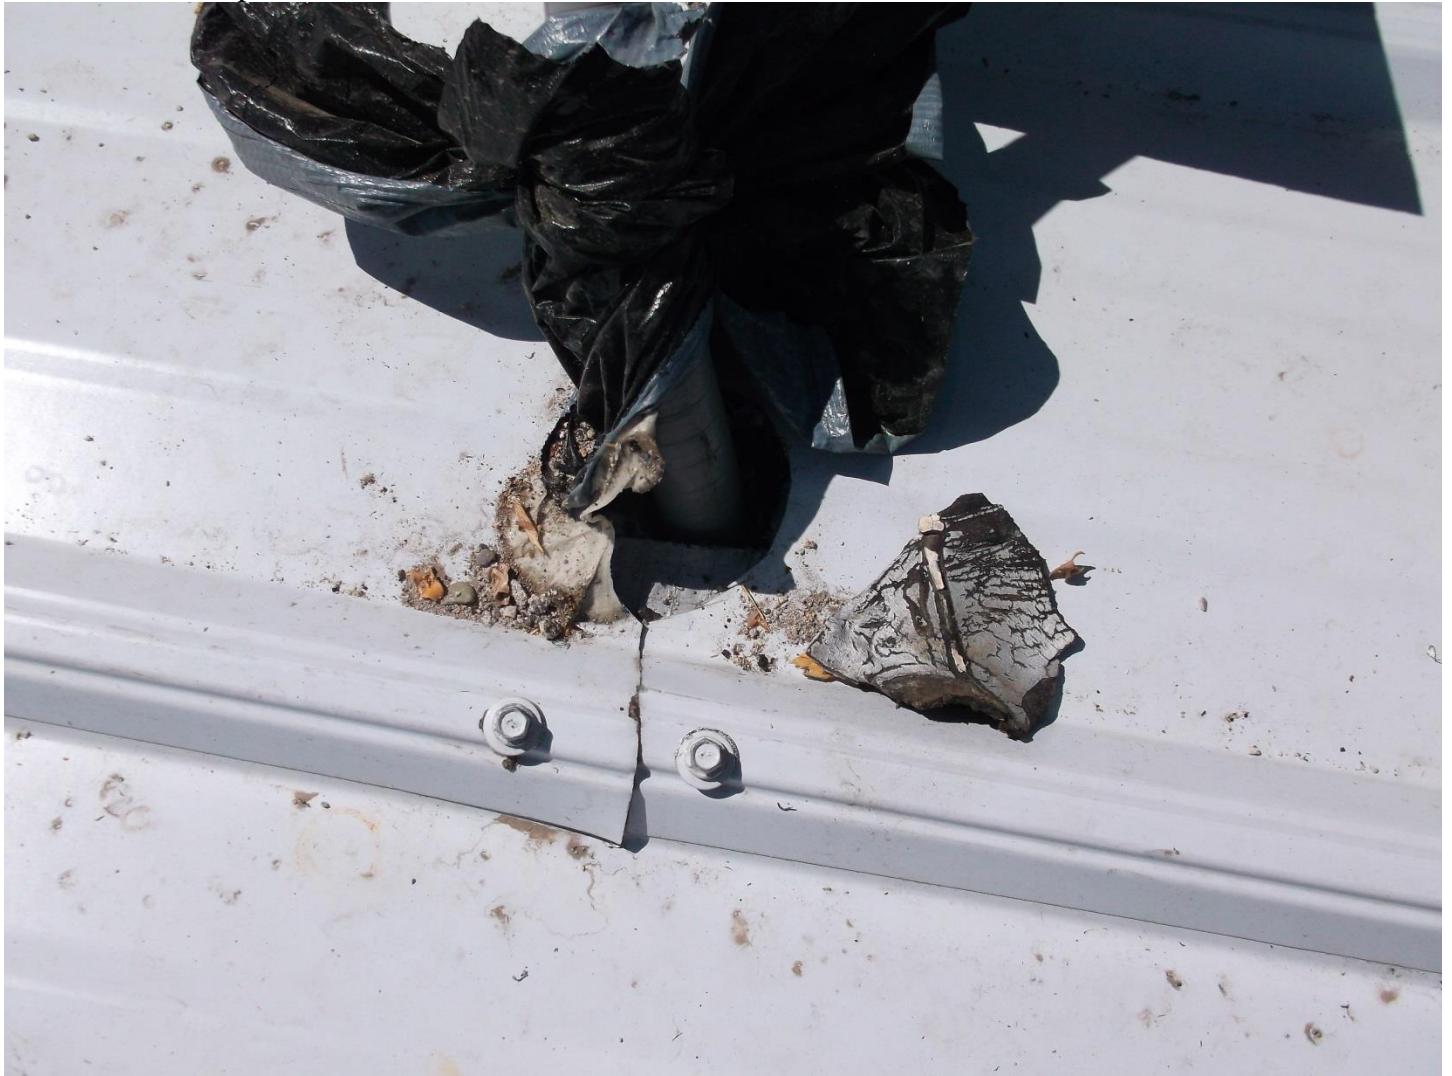
Electrical conduit penetration thru roof
