# **FIRE SUPPRESSION SERVICES, INC.**

## **EXHAUST DUCT DEFICIENCIES.**

The grease exhaust ducting you asked me to inspect at Heritage Gardens Care Center in Springville Utah was, for the most part, inaccessible for inspection.

## **RANGE GUARD SUPPRESSION SYSTEM DEFICIENCIES.**

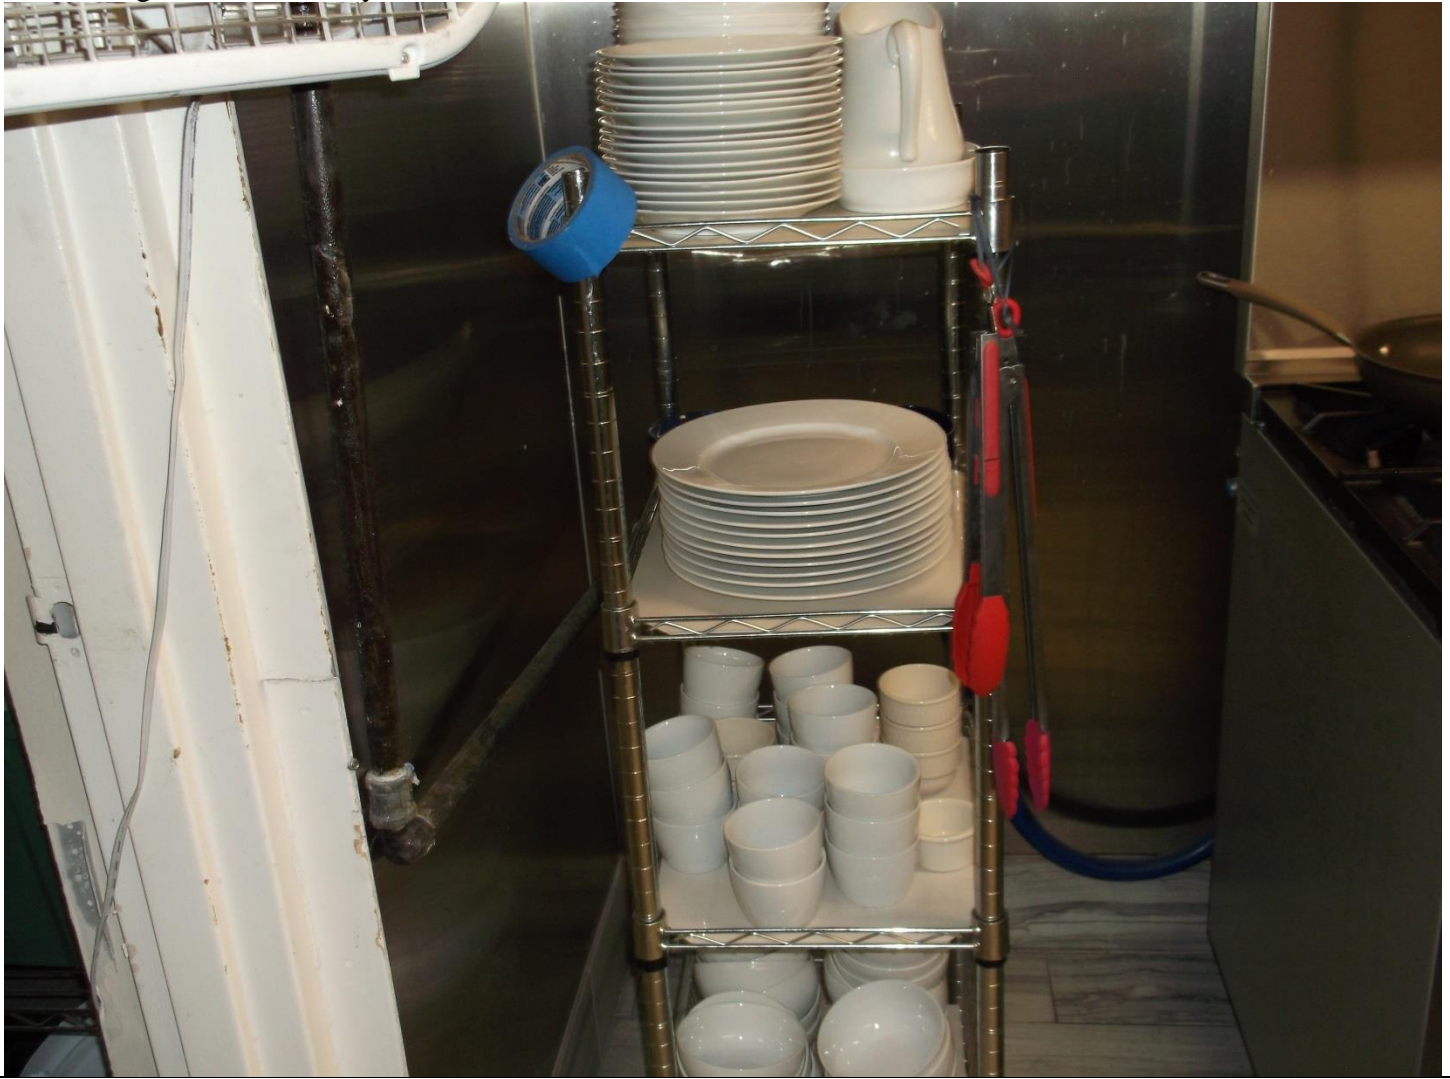
The gas pipe to the cooking appliances needs more support bracing.

Unbraced gas line on wall by door

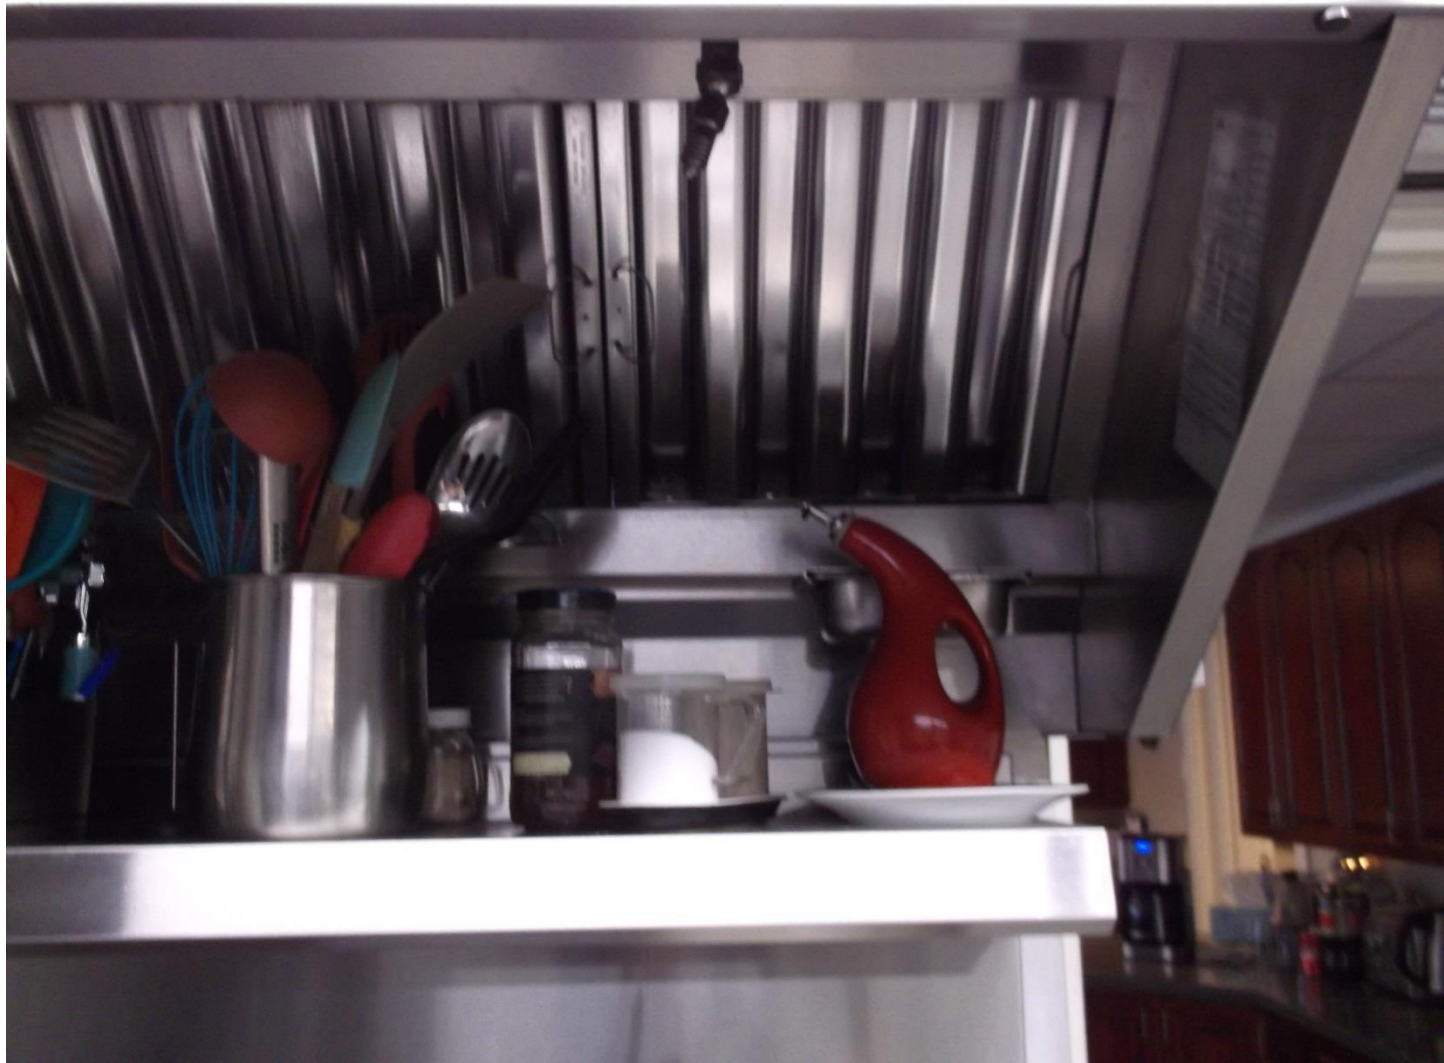
Griddle nozzle

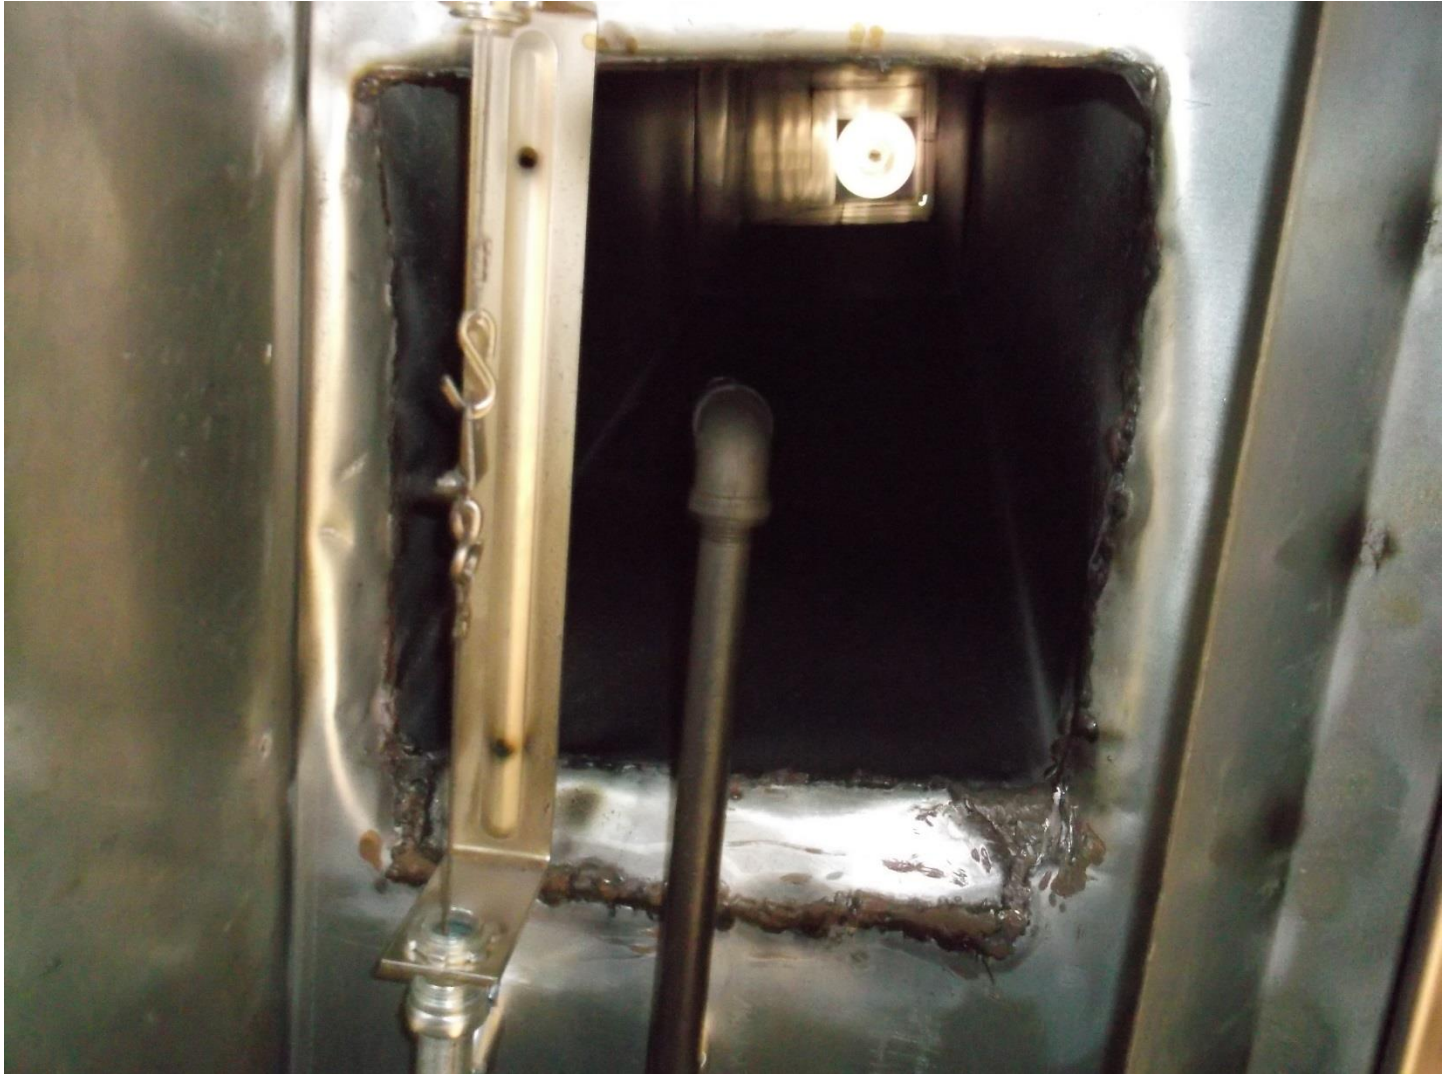
I could see that the older portion had been welded to the hood from inside the plenum; the seams were welded, and had 2 layers of fire-wrap.

## Duct to Hood welds

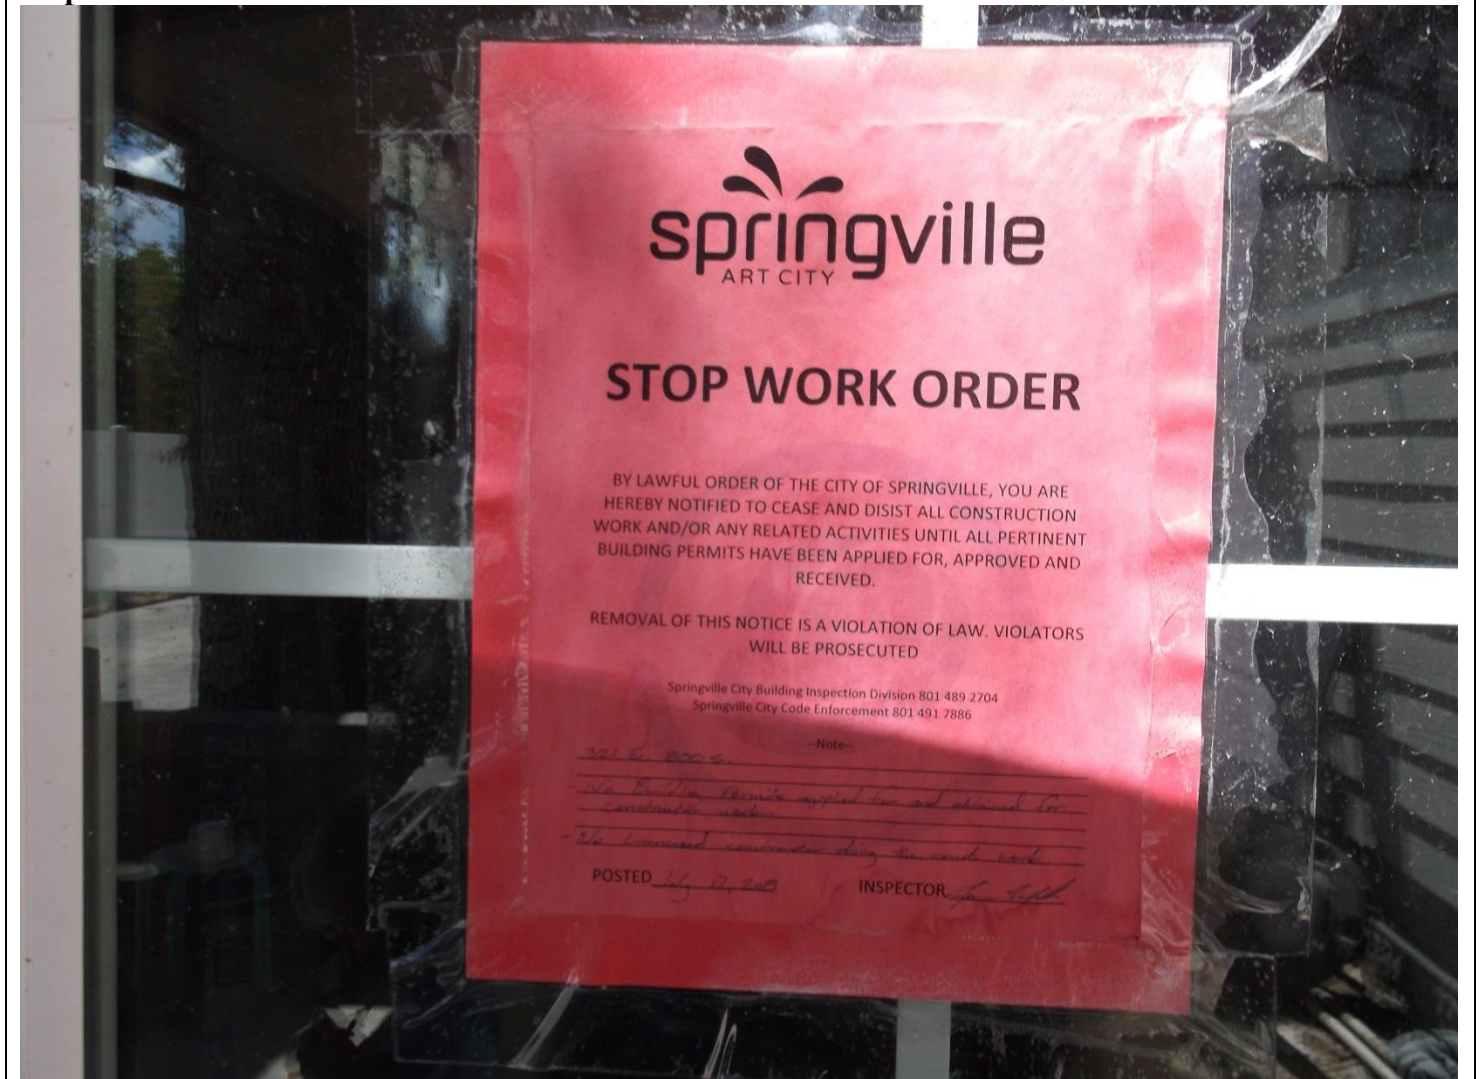
## Stop work order
